## **Technical Memorandum**

### **Ecological and Habitat Health Assessment Wetlands A, B, and C**

**Gulfco Marine Maintenance Superfund Site  
906 Marlin Avenue  
Freeport, Brazoria County, Texas  
EPA Identification No. TXD0055144539**

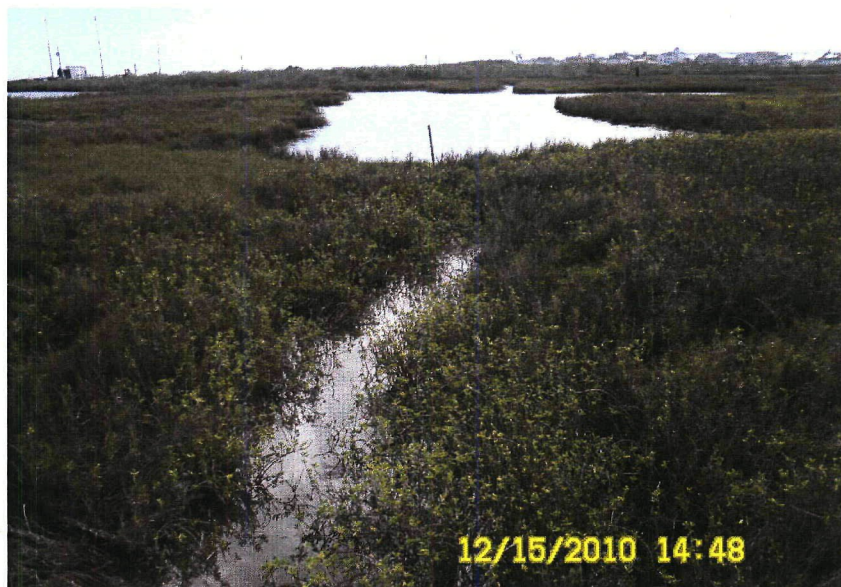
Wetlands A and B are part of the contiguous high marsh/salt pan area between the site and Oyster Creek. These wetland areas were inundated with water (surface to 4 cm below grade), and connecting ditches (wetland A) and marsh pan (wetland B) held several centimeters of water (Photo 1).

Photo 1: Water inundation in Wetland A (foreground) and B

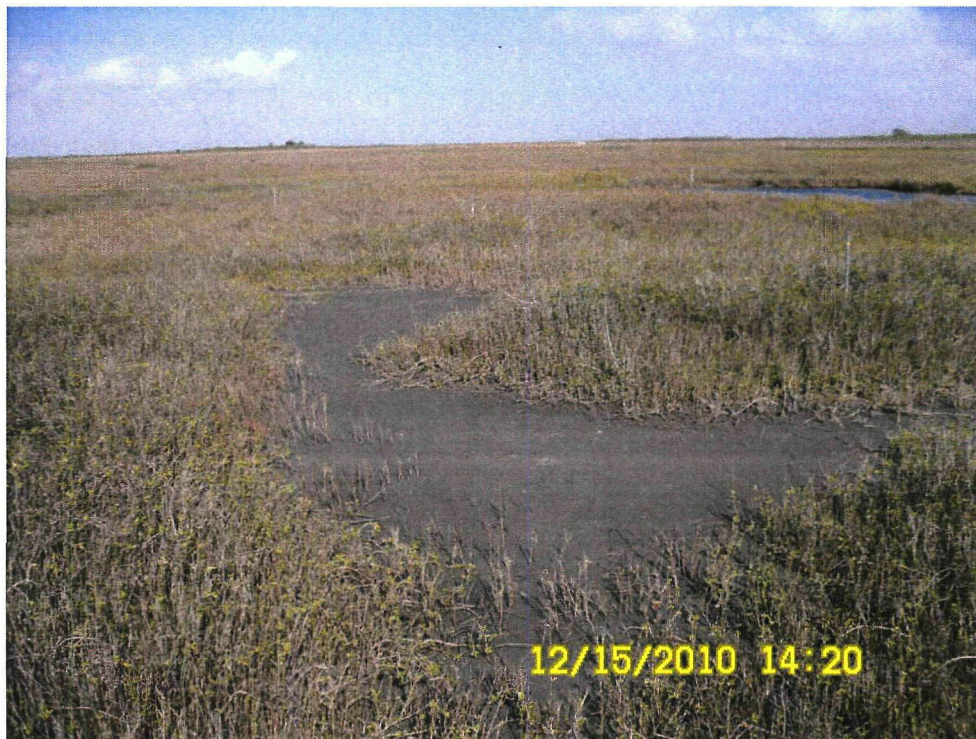
Vegetation was dense in wetland areas interspersed with salt pan (Photo 2). Vegetation diversity and density were not noticeably different between Wetland A/B and surrounding wetlands.

Photo 2: High marsh salt pan

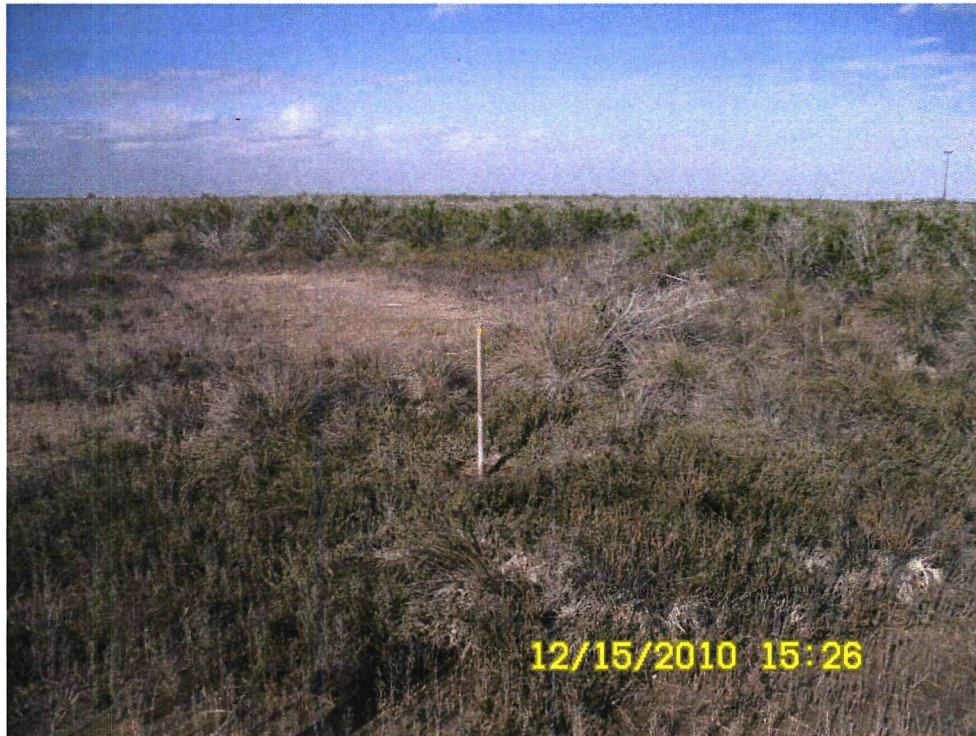
Common facultative wetland vegetation (Table 1) found in Wetland C was present in most areas and similar in extent and composition to surrounding road bordering wetlands (Photo 3).

Photo 3: Wetland C

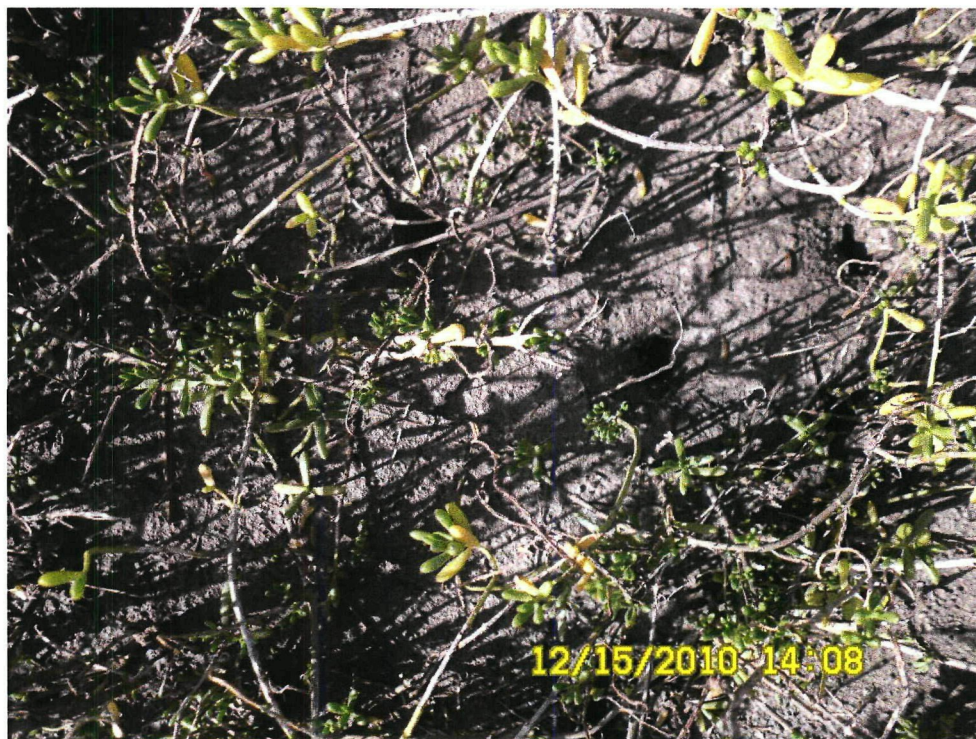
Evidence of benthic macroinvertebrates were observed throughout Wetland A and B. Crab burrows and tube-dwelling organisms were plentiful throughout (Photo 4), with similar densities in Wetlands A/B visually compared to the surrounding areas. Multiple species of crab were observed in Wetland A and B.

Photo 4: Typical benthic macroinvertebrate dwelling density in Wetland B (approximate spacing 10 cm).

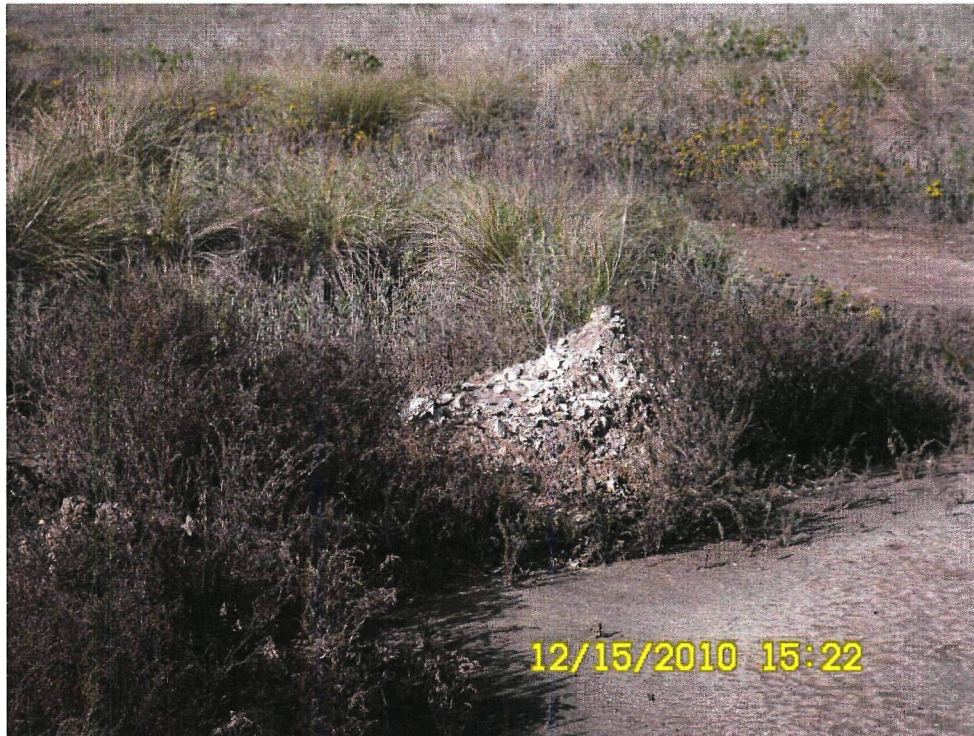
Wetland C, along with other similar wetland areas along Marlin Avenue, has been impacted by fill placement, and some trampling by people, dogs, etc., from the surrounding areas (Photo 5).

Photo 5: Typical disturbance in Wetland C
